PENNSYLVANIA  
NDI NO. PA.00993  
DER NO. 45-148

**RAKES DAM**

PHASE I INSPECTION REPORT  
NATIONAL DAM INSPECTION PROGRAM

Name of Dam:	Rakes Dam
County Located:	Monroe County
State Located:	Pennsylvania
Stream:	Pond Creek
Coordinates:	Latitude 41° 3.4' Longitude 75° 6.2'
Date of Inspection:	March 18, 1981

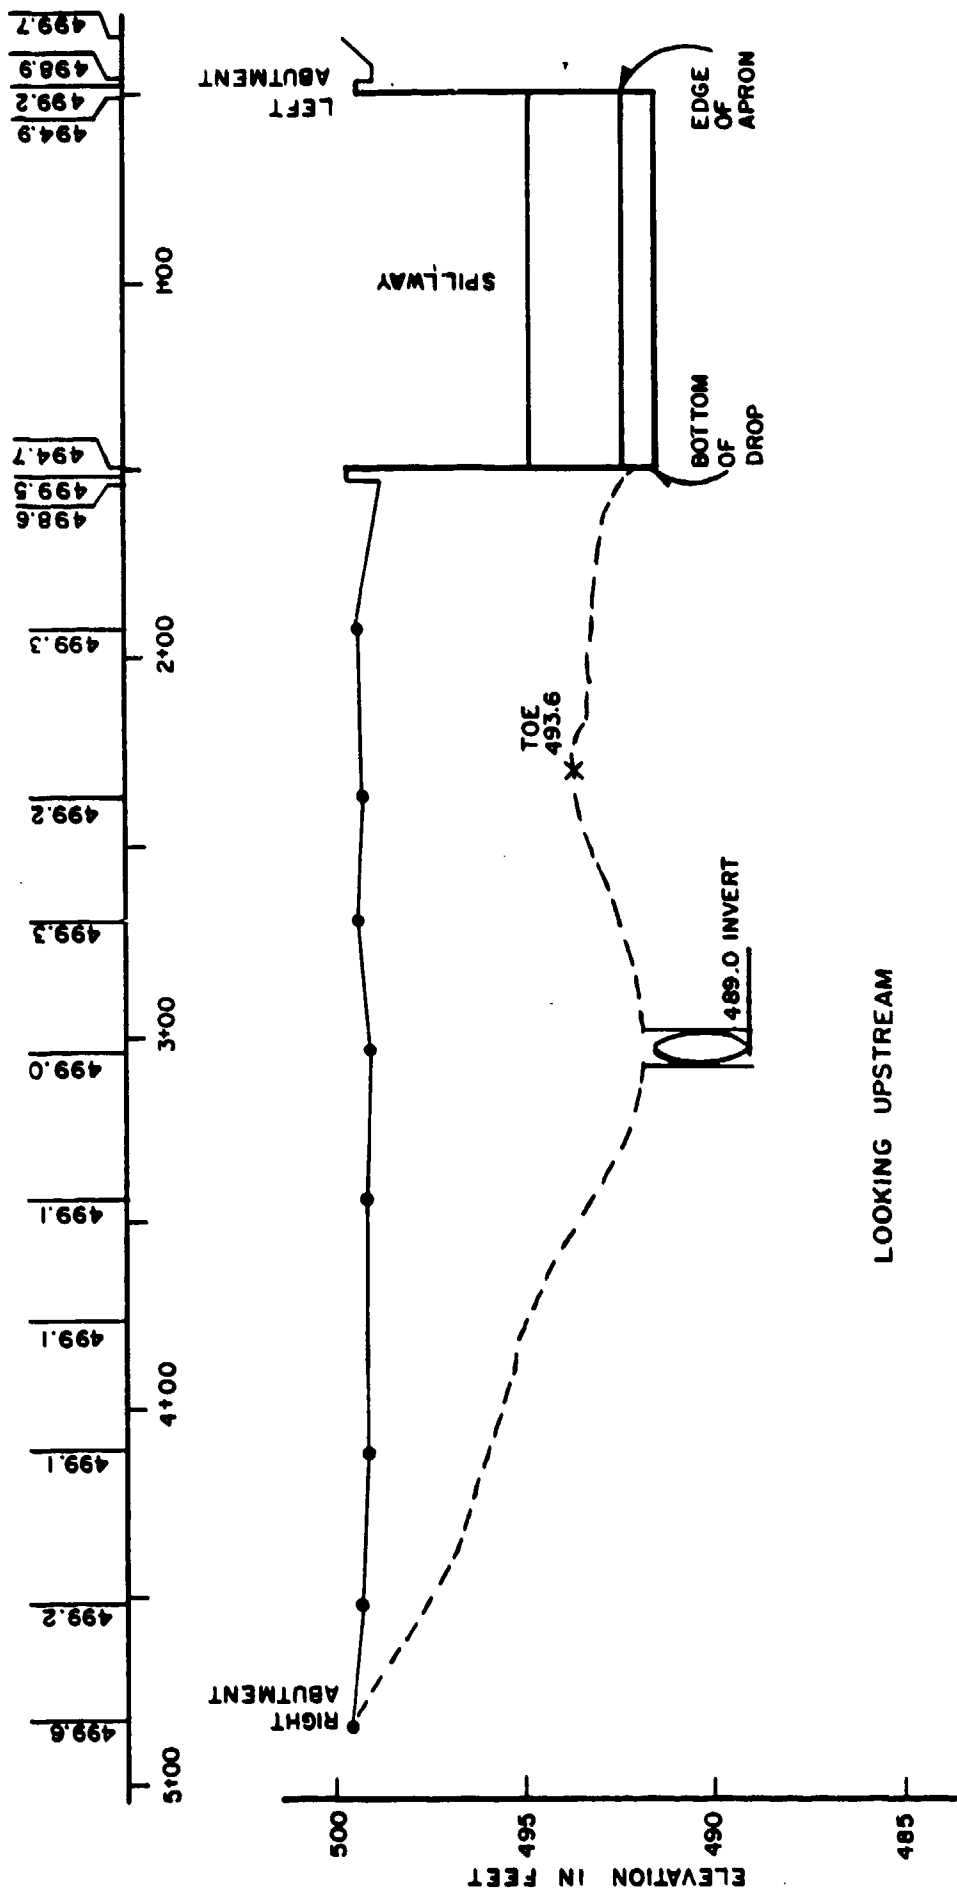
PROFILE ALONG CREST  
RAKES DAM  
SHEET 5C OF 11

b. Dam. The vertical alignment of the dam crest was checked, and the profile is shown on Sheet 5C, Appendix A. There are no distortions in alignment that would be indicative of deep-seated movements of the embankment or foundation. The upstream embankment slope is protected by riprap which has been displaced by brush and trees. Measurements indicated that the upstream slope above the waterline is about 2H:1V. There appeared to be some displacement of riprap at the waterline, possibly the result of wave and/or ice action. Some slight erosion/foot traffic damage was evident adjacent to the upstream side of the gate well. The embankment crest is protected with vegetation and is generally cleared of woody vegetation. No wheel ruts or foot traffic damage was noted. The downstream embankment slope is protected by riprap. In most areas the downstream slope is 2.9H:1V. Trees up to 18 inches in diameter are growing adjacent to the downstream toe and most of the downstream embankment slope is covered with brush and trees. All junctions between the embankments and abutments appeared in good condition and no evidence of damage by foot traffic was noted either at the junctions or on the embankment itself.
